# BENCHMARK PROJECT MANAGEMENT (UK) LTD - CASE STUDY

Small Retaining Wall Reconstruction

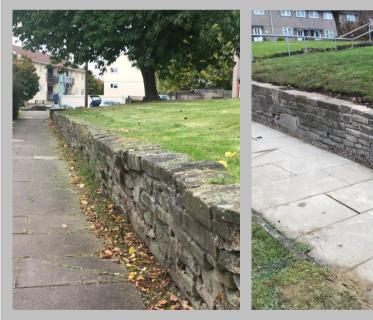
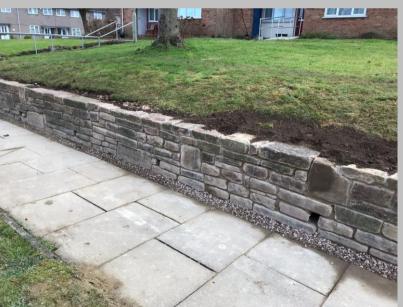
The low retaining stone wall on a busy stretch of path was evidently beginning to fail and desperately needed strengthening. It was also found to be missing any type of current foundations or drainage.

Take down and rebuild the length of retaining stone wall while strengthening and also improving drainage.

- Deconstructed stone wall, clean and set aside the stone for reuse
- Build new concrete block retaining structure inclusive of weep holes
- Implementation of perforated pipe and granular drainage to rear of wall
- Excavated line trench and poured new concrete footings
- Reconstruction of set aside stone blocks to match existing style true and plum
- Adjusted existing slabs to accommodate for granular drainage
